# BRADCO Service Bulletin

There has been an update to the BRADCO Skid Steer Loader Swing Hoe. Due to reports of external leaking of the valves on the swing hoe the hardware connecting the valves has been changed to four .31" UNC X 4.75" Socket Head Capscrews, eight flat washers and four deformed lock nuts. **NOTE: When replacing your existing .25" hardware check o'rings between valves for damage and replace if necessary.**

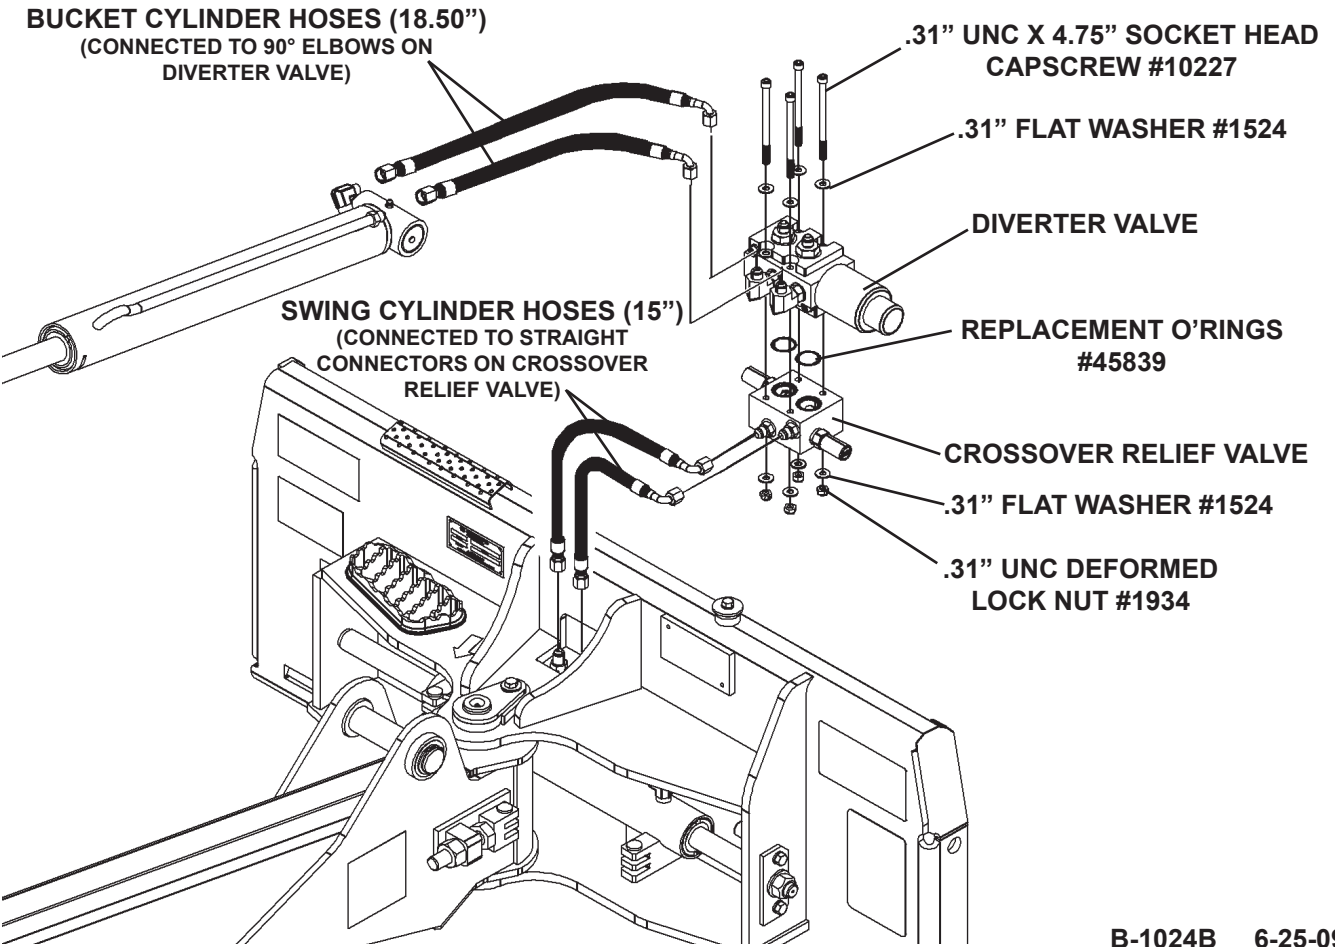
See the diagram below to verify hose routings to the bucket cylinder and to the bulkhead fittings going to the swing cylinder. These hoses are not interchangeable due to the hose length. If these hoses are switched around on your unit, please reroute as shown to prevent hose damage and to achieve the desired operating function of swing left and dump.
